Property Condition Report

Inspection Date: 12/17/2016 Con

Address: 136 GLENSIDE DR Stockbridge, Ga 60490

Subject: Home Inspection Report

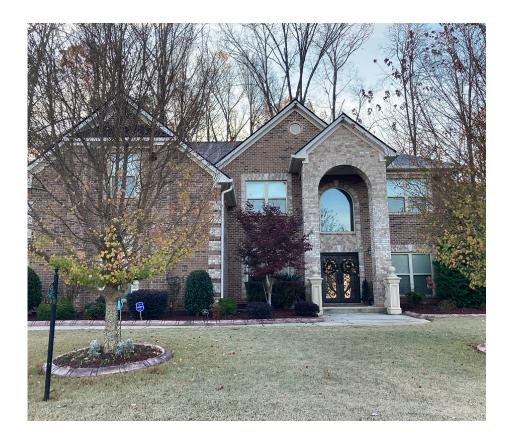
The Subject Property is in SIMILAR condition compared to the neighborhood. The Subject Property is observed to be in GOOD condition.
